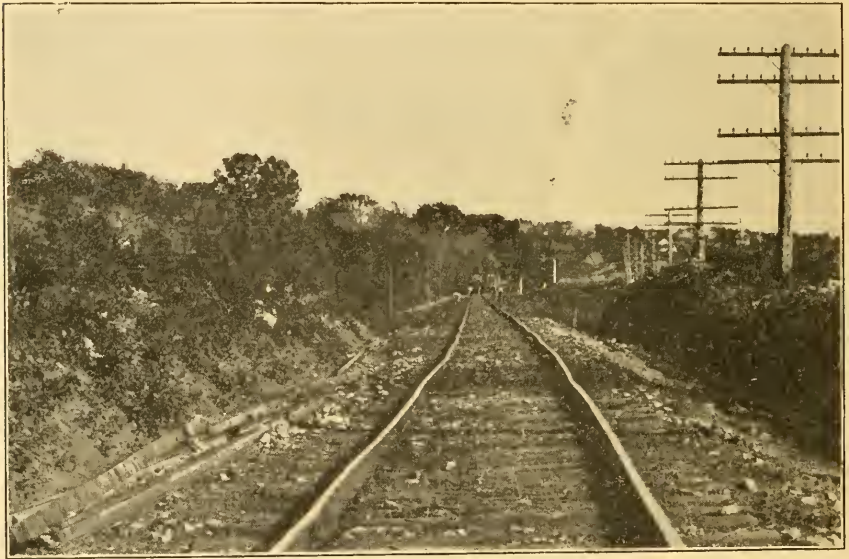
No. 1.—View of track approaching point of derailment from the north.

The track for a distance of one-half mile on each side of the point of derailment was found to be in bad condition, and in many instances the gauge was tight at the rail joints while at the centers the rails were spread outward. In some of these cases the gauge at the joints was 4 feet 8 inches, while at the centers it was 4 feet 9 $\frac{1}{4}$  inches. This condition is shown in illustration No. 1, a view taken from the north, looking toward the point of the accident. Illustration No. 2 shows a similar condition existing south of the point of derailment. Two rails were found with crescent-shaped breaks in the flange on the inside, one 6 inches in length and one 11 inches in length. About 50

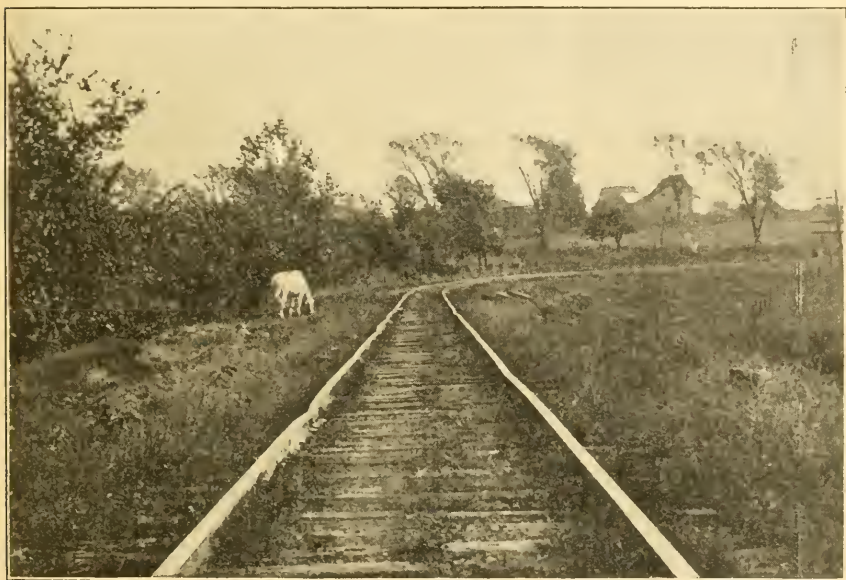
No. 2.—View of track south of point of accident.

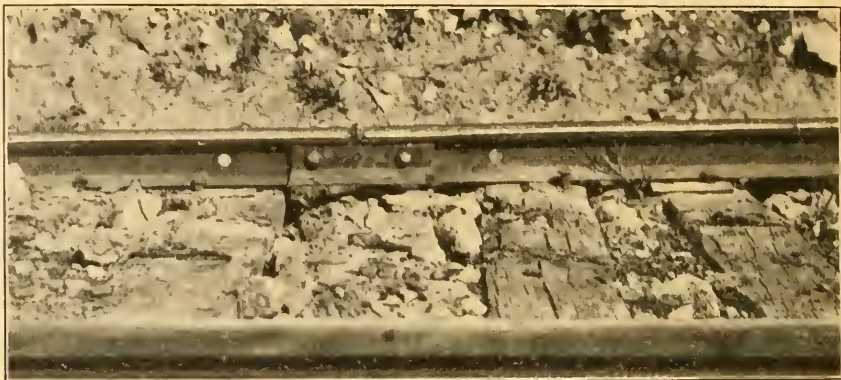
angle bars were found having only one or two bolts in them, this conclusion due to the fact that some of the rails had no bolt holes in them, while others were so badly matched that the holes in the angle bars did not register with the holes in the ends of the rails. Illustration No. 3 shows the use of a broken angle bar at a rail joint, while illustrations Nos. 4 and 5 show the use of angle bars in cases where no bolt holes were drilled in the rails, or the bolt holes in the rails did not match with the holes in the angle bars. Twenty-five angle bars were found in this mile of track which were broken or badly sheared, while in some cases there were spaces of as much as 2 inches between the ends of the rails.

No. 3.—Use of broken angle bar at joint.

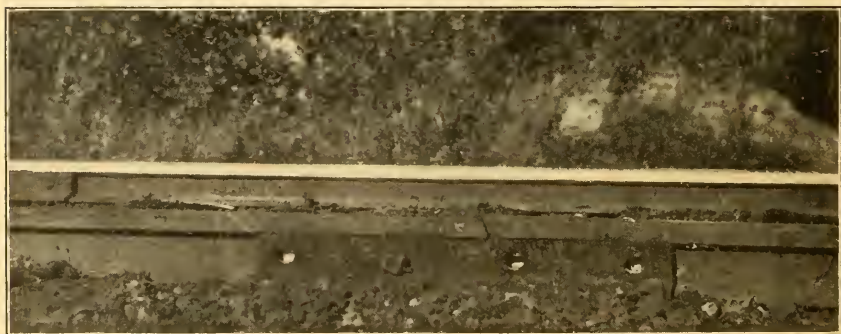
No. 4.—Use of angle bars not matched with holes drilled in rails, or where no holes had been drilled in rails.

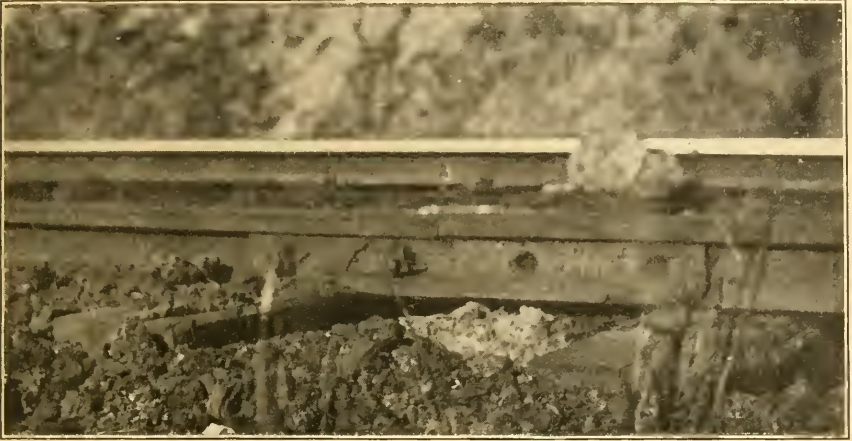
No. 5.—Improper use of angle bars; same condition as shown in figure No. 4.

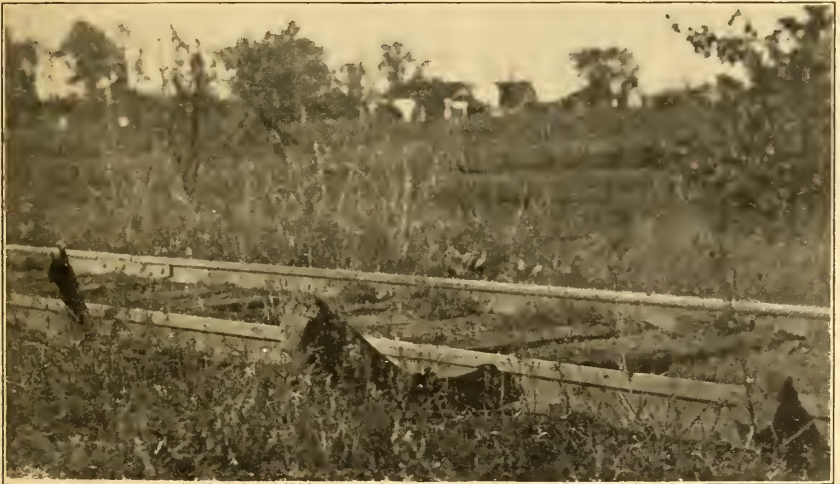
This examination of the track also developed a poor condition of spiking. Many could be drawn by hand, while in other places five or six consecutive ties had no spikes in them. It was also found that in some places spikes had been loosened until they were from three-quarters of an inch to 1 inch away from the base of the rail; in one rail only two spikes out of 17 consecutive spikes on the inside of the rail were holding the same. Many ties were found which were not in serviceable condition, the ends being broken off. Illustration No. 6 shows the ends of broken ties which had been allowed to remain in the track.

No. 6.—Ties remaining in track with ends broken off.
